Manhole Inspection Summary

Manhole # S35KK_008MH

Insp Date: **3/9/07 11:26 AM**

Location Address: **310 LAFAYETTE AVE**

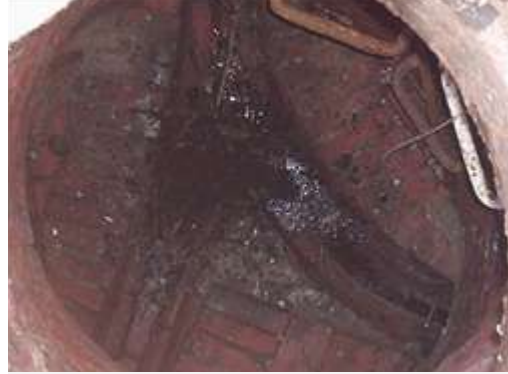
Top View

Bench ☒ Exists Material: **Brick** ☐ Parged ☒ **Debris** (not Condition related)

Channel Material: **Brick** ☐ Parged ☒ **Debris** (not Condition related)

Steps Count: **4** Missing: **0** ☒ **Corroded**

Corroded steps. Bench and Channel debris.

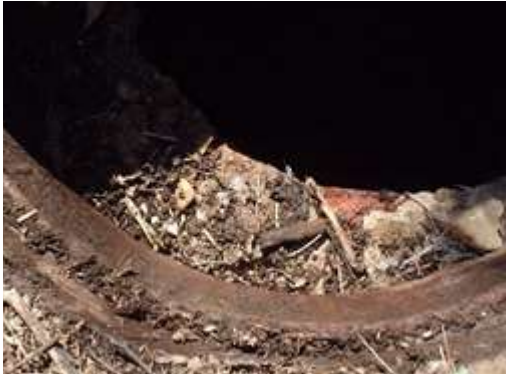
Defect

Frame Offset: **5** (in.)

☒ **Leaks**

Frame leaks. Frame offset.

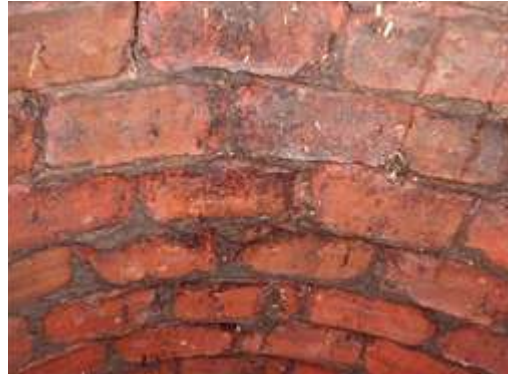
Defect

Condition: ☐ Sound ☐ Cracked ☐ Root Intrusion ☐ Loose Brick ☒ **Deteriorated**

Infiltration: ☐ None ☒ **Joint** ☐ Cracks ☐ Mortar ☐ Roots ☒ **Wall**

Corbel deterioration and infiltration.

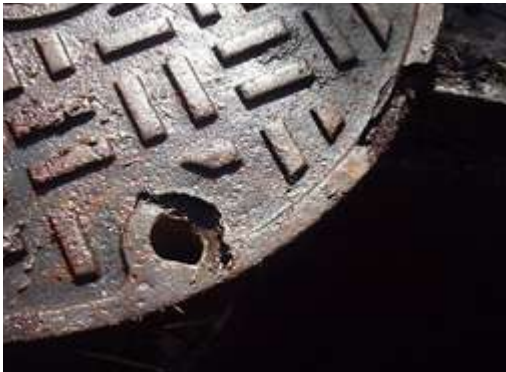
Defect

Condition: **Worn**

Worn manhole cover.

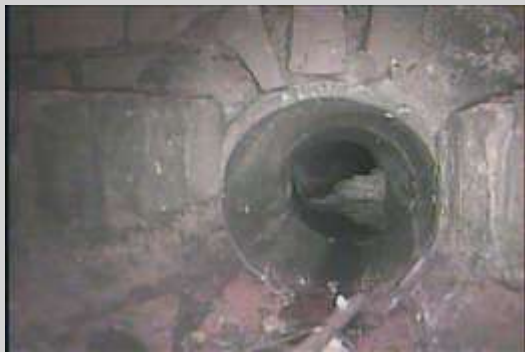
8 in. Circular Gravity Sewer Pipe Out @ 12 O'Clock

Deposits: ☐ None ☐ **Mud** ☐ Sludge ☒ **Debris** ☐ Grease

Silt Depth: **0** (in.) Deposits Extent: **Light**

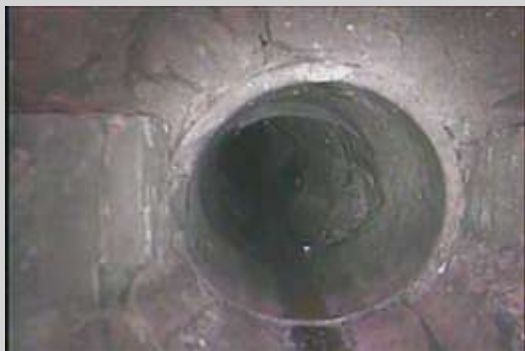
8 in. Circular Gravity Sewer Pipe In @ 4 O'Clock

Infiltration: **None** Pipe Seal Cond: **Cracked**

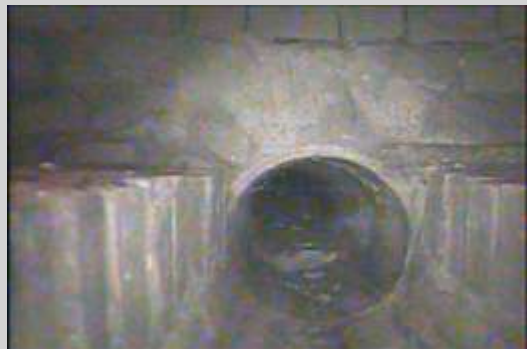
Pipe In @ 7 O'Clock

Deposits: ☐ None ☒ **Mud** ☐ Sludge ☒ **Debris** ☐ Grease

Silt Depth: **1** (in.)

Deposits Extent: **Light**
